BLAST TESTS OF EXPEDIENT SHELTERS IN THE DICE THROW EVENT, (U)

ORNL-5347

## Blast Tests of Expedient Shelters in the DICE THROW Event

Cresson H. Kearny  
Conrad V. Chester

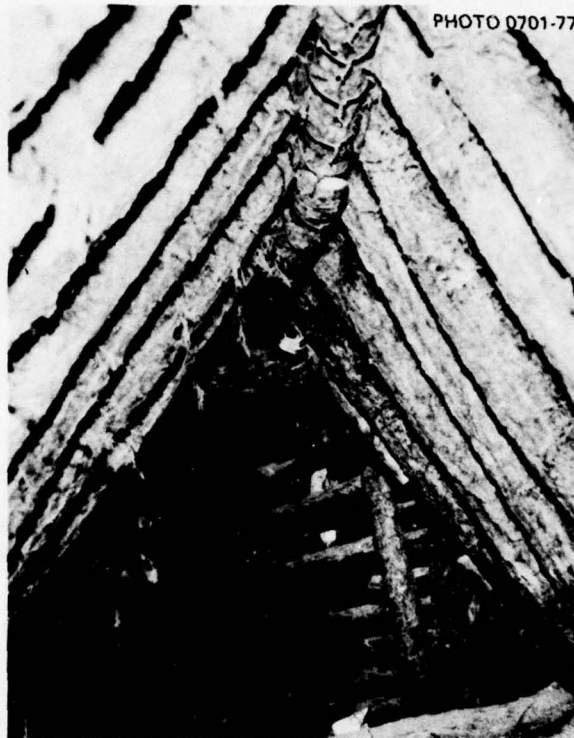
Fig. 11.8. Posttest view of opening at bottom of triangular vertical entry, undamaged by 20-psi blast effects.

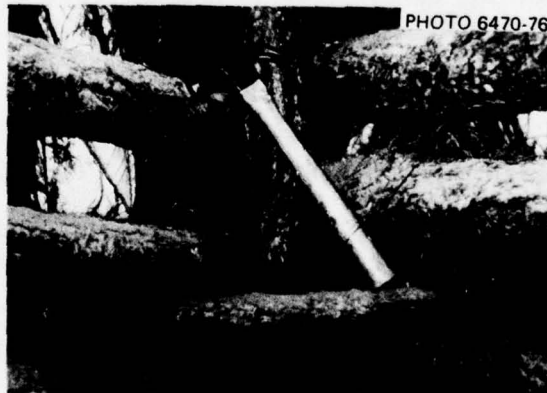
Fig. 11.9. Postshot condition of the lightly constructed triangular vertical entry. The hammer rests on a step pole. Earth arching prevented the yielding bed sheet outside from being torn.

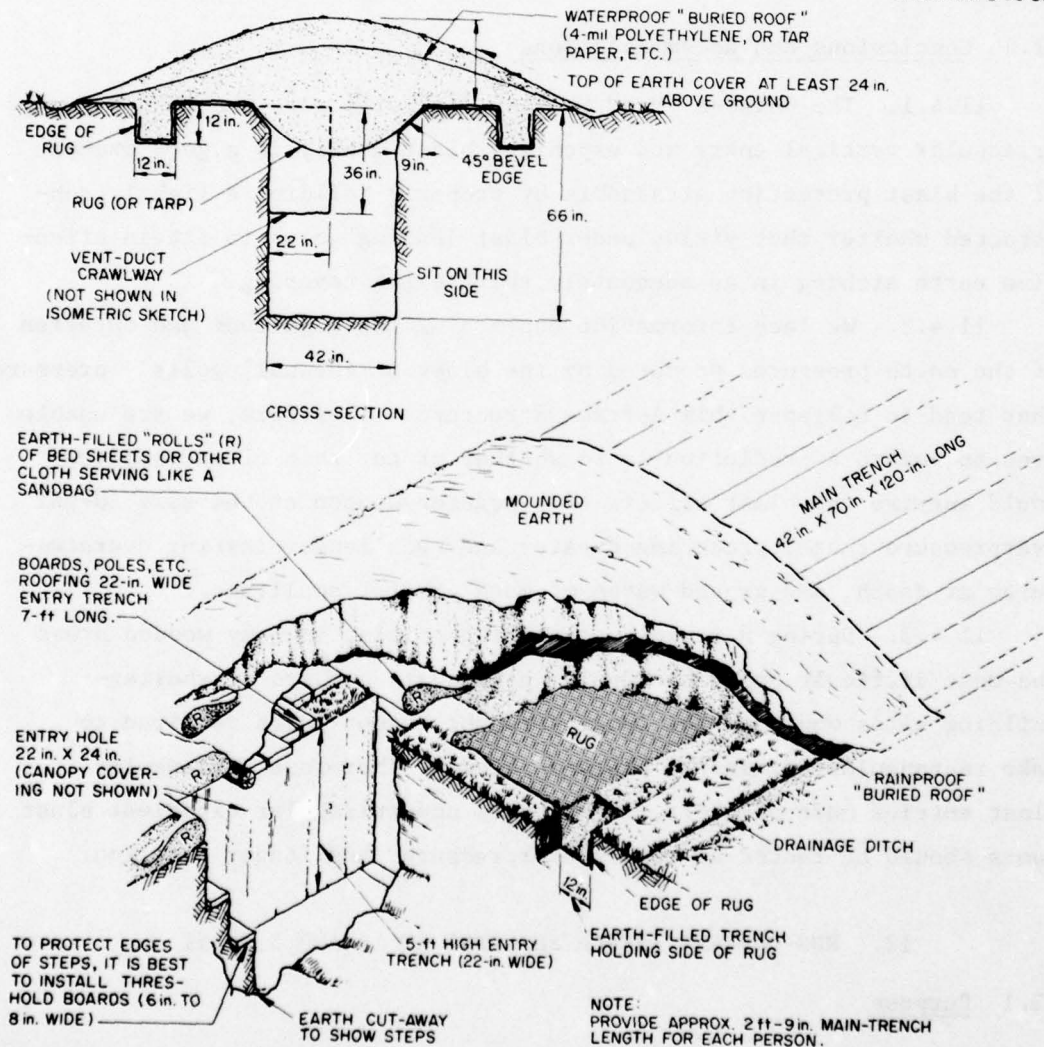
Fig. 12.1. Construction of Rug-Covered (or Tarp-Covered) Trench Shelter.

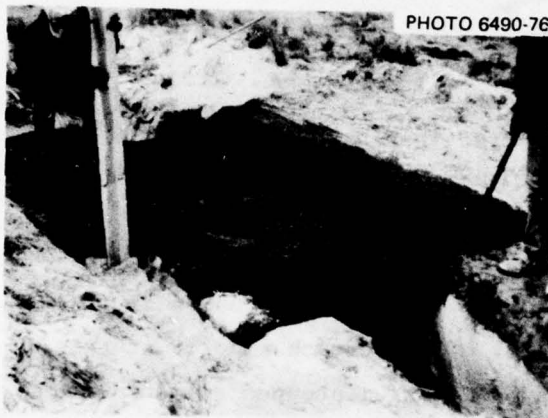
Fig. 12.2. Tamping earth over edge of a side trench of Rug-Covered Trench Shelter at 15 psi.

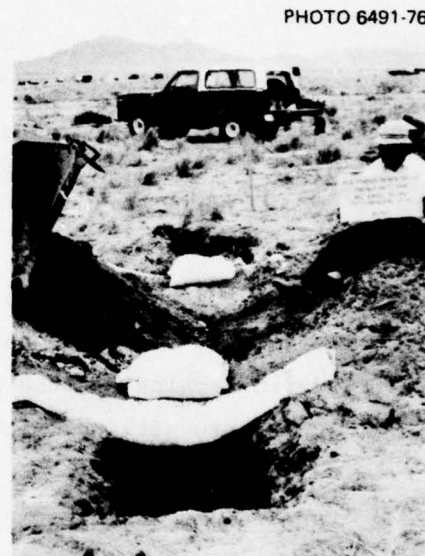
Fig. 12.3. Dumping earth on side of rug before mounding earth 4 ft deep along centerline. An earth-filled bed-sheet "roll" and a pillowcase "sandbag" retained earth at each entry, pictured prior to completion.

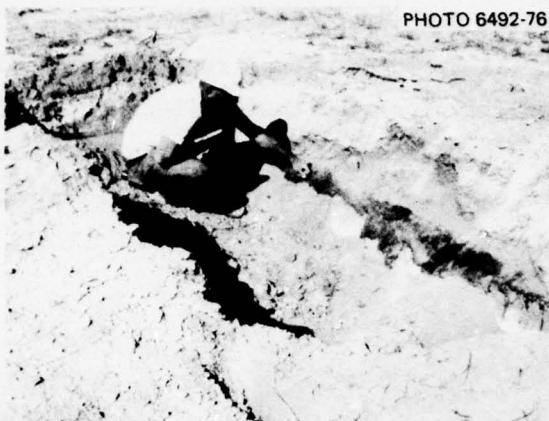
Fig. 12.4. Demolished Rug-Covered Trench Shelter at 15 psi. The edges of the rug were not pulled loose by blast effects; it was torn lengthwise.

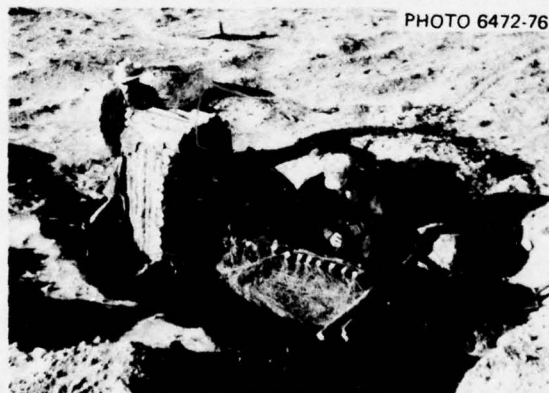
Fig. 13.1. One-half-scale Chinese "Man" Shelter tested at 31 psi with its triangular blast door closed. Before being covered with earth mounded as high as the blast door, the whole shelter was covered with 4-mil polyethylene.

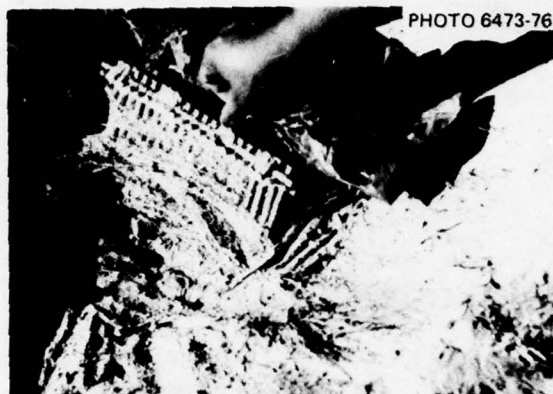
Fig. 13.2. One-tenth-scale room of Chinese "Man" Shelter at 31 psi, photographed posttest. The frame had remained adequately covered, was undamaged, but had been pushed about halfway into the ground.

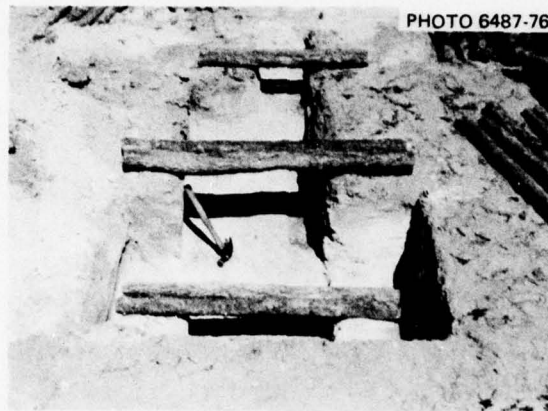
Fig. 13.3. Construction of one-half-scale Log-Covered Trench Shelter at 53 psi. The Chinese way of placing roofing poles below ground level is shown in front; the Russian way, to the rear.

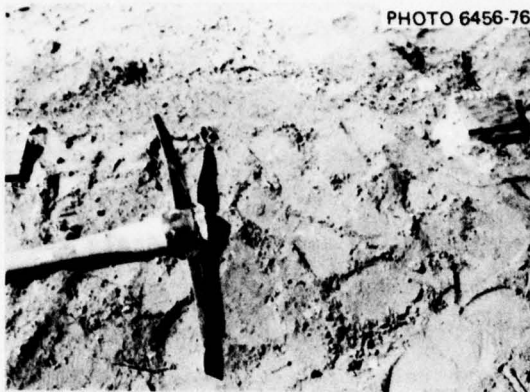
Fig. 13.4. One-tenth-scale Small-Pole Shelter, pretest at 106 psi. Earth was mounded over this shelter at slopes of about  $10^\circ$  to minimize blast-wind scouring. Only the plywood blast doors are visible.

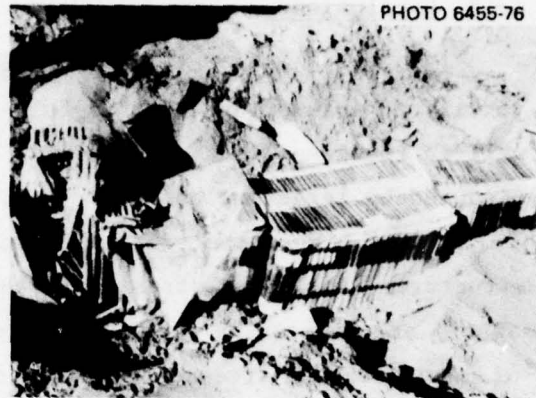
Fig. 13.5. One-tenth-scale Small-Pole Shelter, posttest at 106 psi, shown after being carefully uncovered.

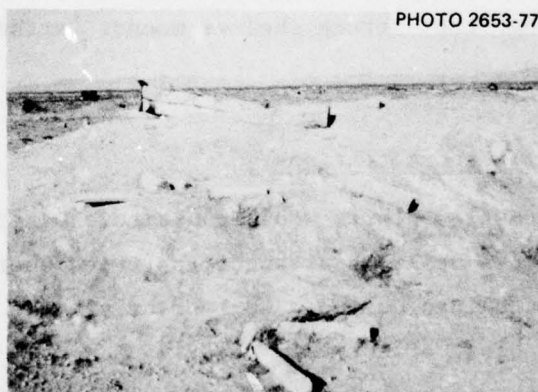
Fig. 14.1. Some of the fireplace-size logs hurled from a woodpile and embedded in the 5-ft-high mound at 53 psi. Apparently, the blast winds of the negative phase had uncovered the two small logs in the foreground and moved them toward ground zero.

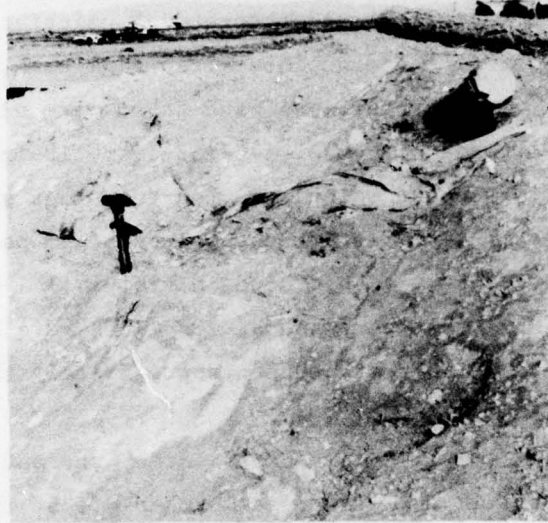
Fig. 14.2. Posttest condition of the side facing ground zero of the 5-ft-high mound of earth over Log-Covered Trench Shelter at 53 psi. The log sticking out of the mound had been hurled by the blast winds. The canvas had been covered with about 4 in. of earth, in a marginally successful attempt to reduce blast-wind scouring.

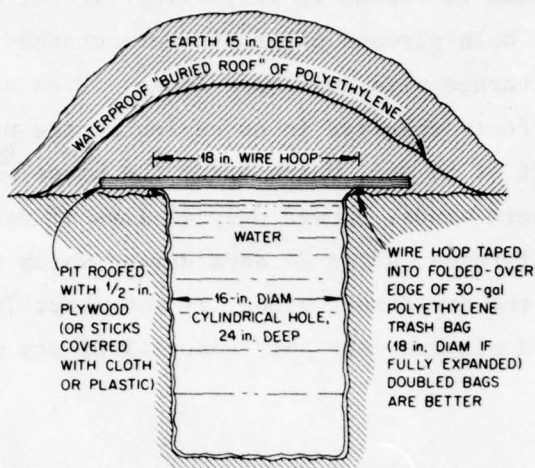
Fig. 16.1. Vertical section of cylindrical water storage pit lined with waterproof plastic bag, or two bags.

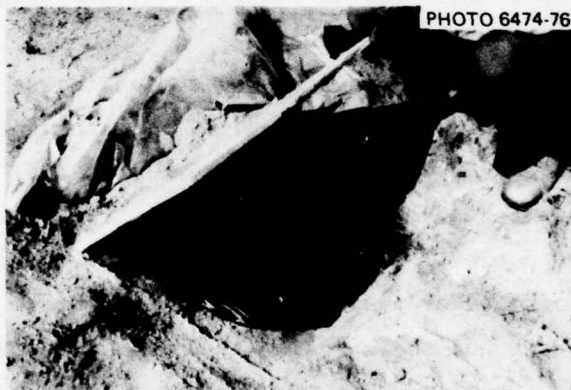
Fig. 16.2. Cylindrical water storage pit lined with two polyethylene trash bags. After exposure to blast effects at 20 psi, this pit was undamaged and still full of water.

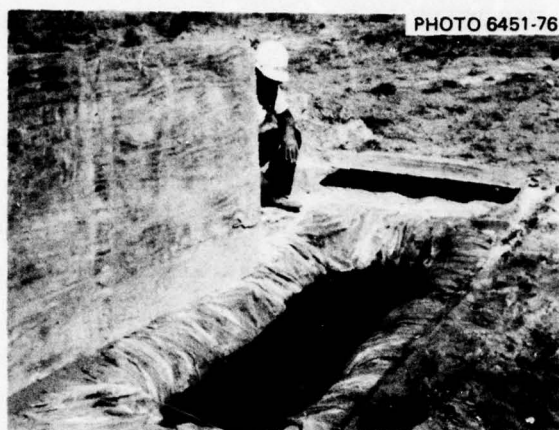
Fig. 16.3. Postshot view of plastic-lined water storage pit at the 6.7-psi overpressure range.

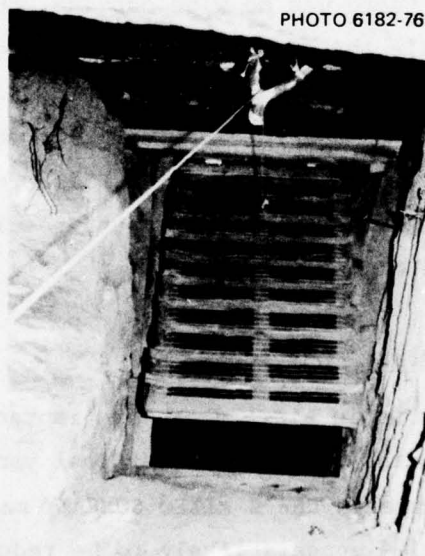
Fig. 17.1. Expedient shelter ventilating pump (a 20  $\times$  36 in. KAP) in an entry of the Log-Covered Trench Shelter at 53 psi. Tested pre-blast, it pumped 177 cfm through the valves of the two closed blast doors and 412 cfm with the doors open. This entry was demolished by blast effects.

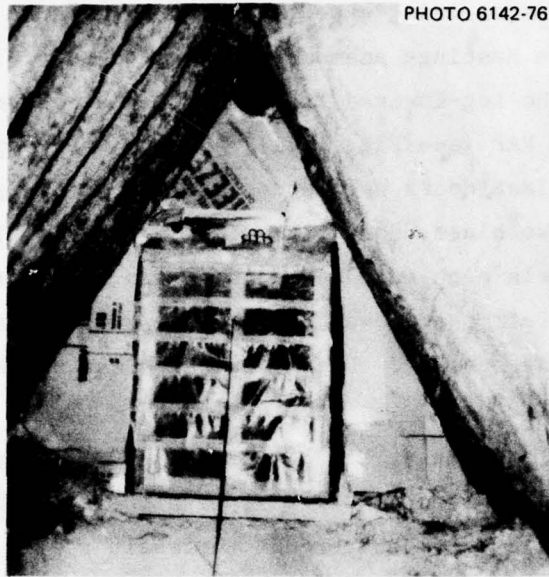
Fig. 17.2. Expedient KAP (20 x 24 in.) tested in the Chinese "Man" Shelter at 20 psi, after the blast.

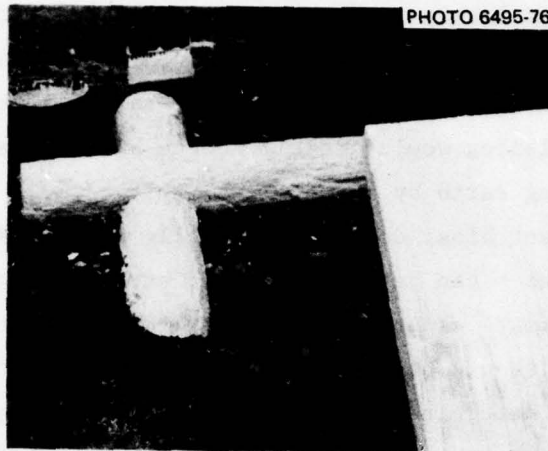
Fig. 18.1. Parts of a blast door and its blast-protector logs whitewashed with a thick slaked-lime paste. This is a proven effective means for making wood much more difficult to ignite.
